1.0 INTRODUCTION

More than 200 gallons of heating oil was lost from an AST in the garage at a residence. The oil primarily flowed from the tank location to the gravel and soil under the garage slab. The oil is believed to have seeped under the slab through the stone beneath the slab. An area of elevated PID readings under the garage floor slab was documented. Strong petroleum odors in the garage were still present, nine months after the initial release. This report documents remedial actions completed to address vapors beneath and in the garage.

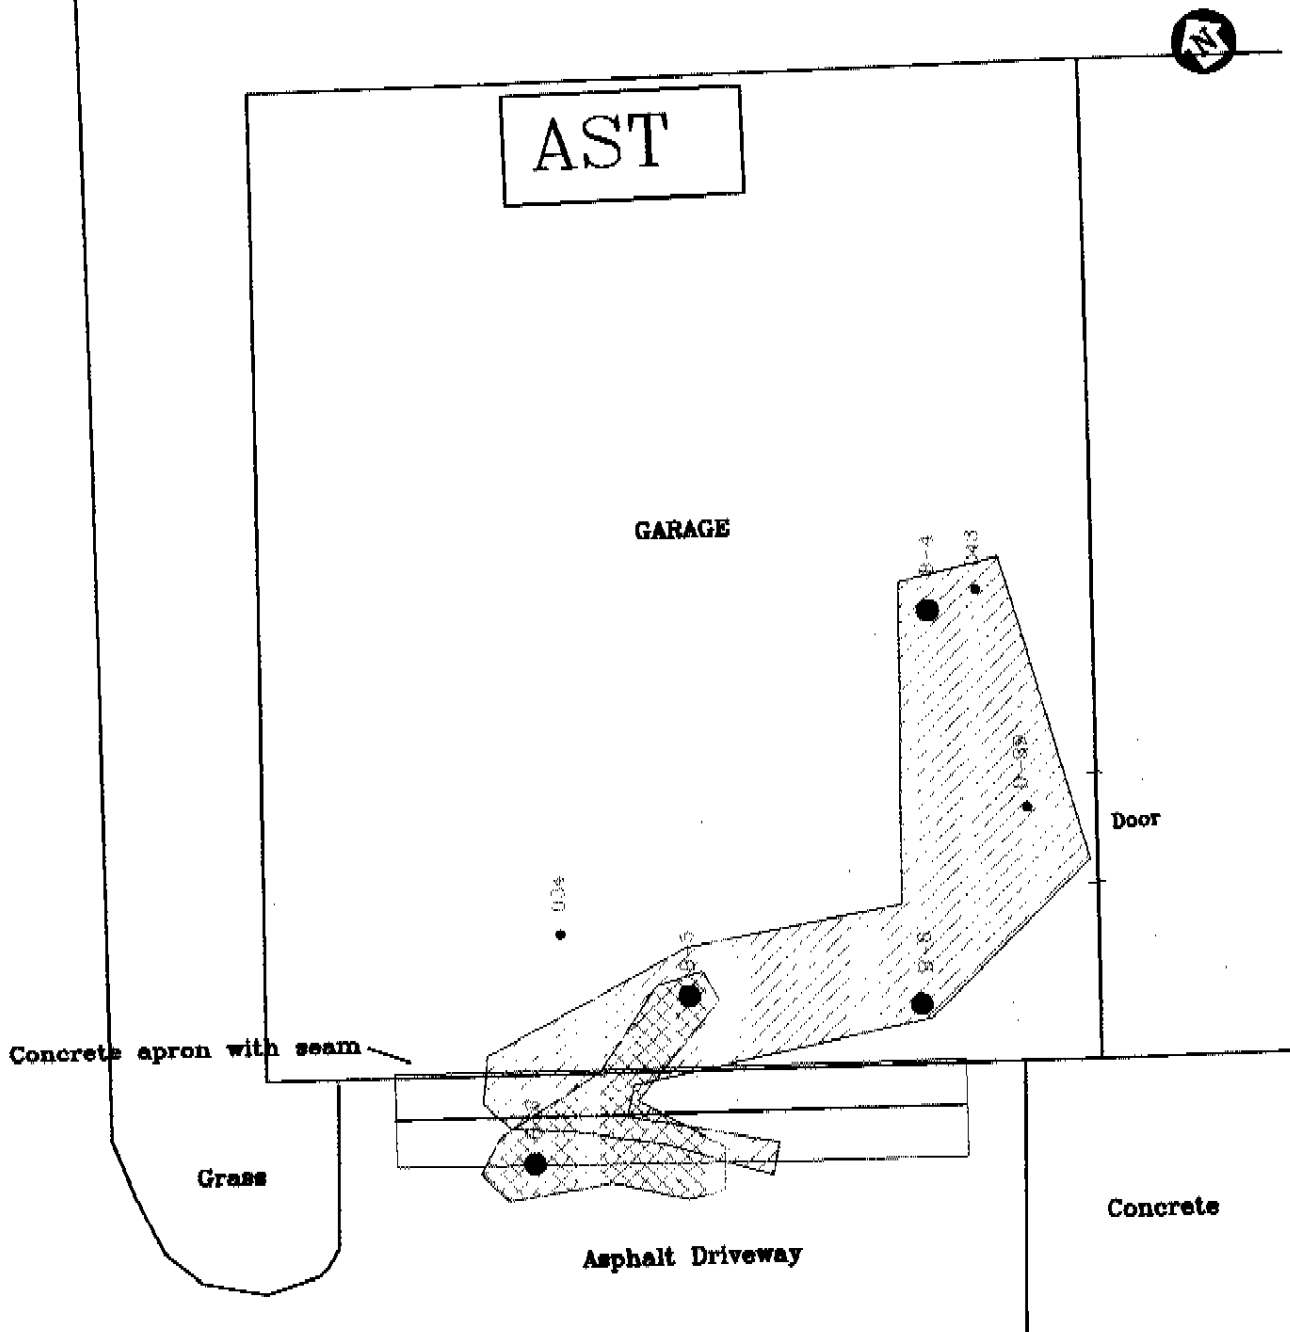
Figure 1

Bioremediation applications was started to treat the oil and vapors below the garage slab. Three holes previously used for PID measurements were re-drilled into the garage floor at locations D1, D2, and D3, shown in Figure 1. CO₂ and PID reading were taken as bench marks prior to treatment of the contaminated area under the garage slab. Carbon dioxide readings were conducted by Drager tubes for CO₂, and the PID readings were made by carefully inserting the probe tip into the drilled hole after calibration.

Four additional holes were redrilled for adding the bioremediation product. These holes were drilled at soil sample locations B4, B5, B6, and B7 for the SCR Addendum. These locations are also shown in Figure 1.

A bio-treatment solution consisting of five gallons of product called VaporRemed and 25 gallons of water was prepared. Plastic tubes were inserted into the feed holes B4, B5, B6, and B7, and the entire 35 gallon solution was siphoned into the holes to the sub-slab stone. It was observed that location B6 would not take any liquid. The fluid was applied at a flow rate of 6.25 gallons an hour approximately.

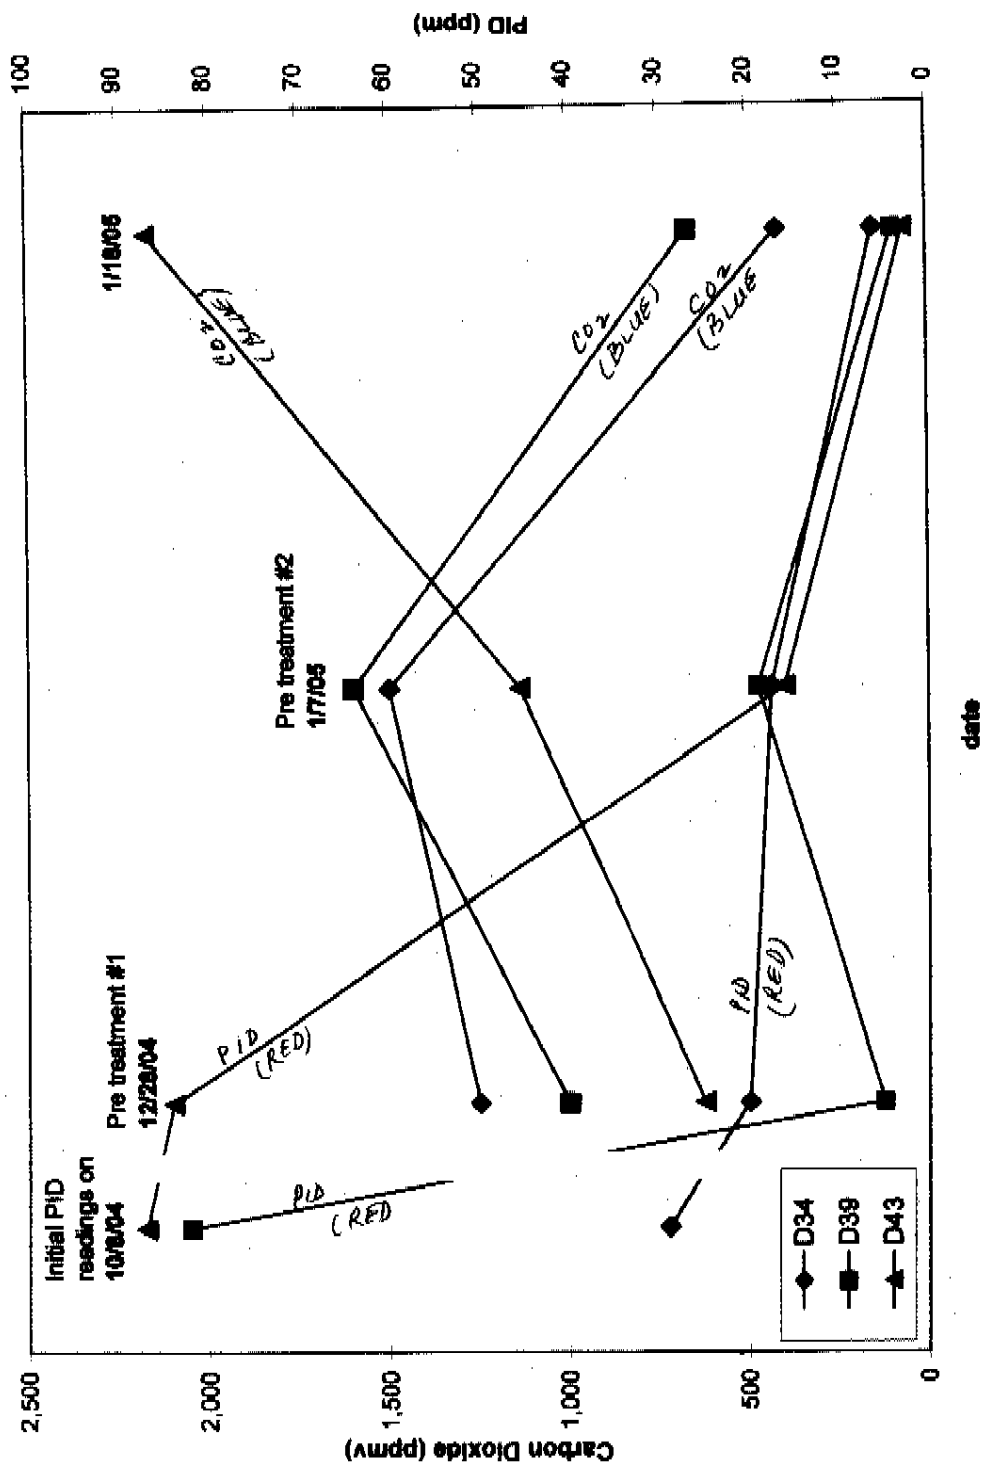
Figure 2. Residence PID and CO₂ values in air below garage slab

The results for PID readings and CO₂ readings are also shown in Figure 2 by red trend lines and blue trend lines respectively. The reading from D2 prior to the first application was anomalously low compared to its initial reading during the SCRA phase and subsequent readings. Except for this one reading, all three monitor points show systematic declines in PID readings.

The data show a dramatic acceleration in the rates of vapor decline after introduction of the 'Vapor Remed' product.

Concomitant with the decline in PID readings after the initial 'Vapor Remed' application were increases in carbon dioxide concentrations. Carbon dioxide continued to increase at the most contaminated location, D3, but decreased during the latter part of the treatment period in the other two locations. The initial increase in CO₂ is inferred to result from the accelerated biologic degradation of hydrocarbons to carbon dioxide. When available hydrocarbons decline, the rate of degradation, and rate of CO₂ production, necessarily declines. The continued increase in CO₂ in the most contaminated area suggests that active bioremediation was continuing in this area.
