Oil Spill Clean-up by Homeowner in Ohio*

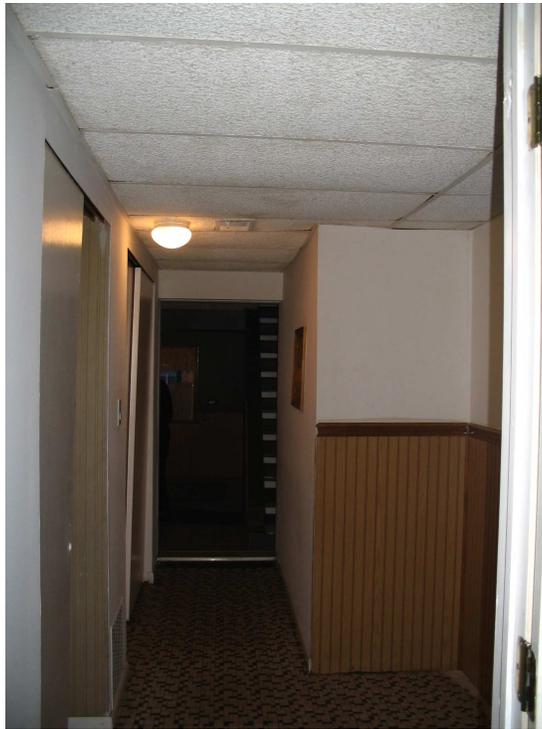
HALLWAY WITH OIL TANK AND ENCLOSURE (NOVEMBER 2005)

This picture is taken before we purchased the property. The house is built on a slab foundation. There was a fuel oil furnace located on the left side of this hallway. The oil tank was behind this enclosure on the right side of the hallway. It appears to have originally been *outside* the house, and then it was enclosed when an addition to the original house was made. Note the small 1 foot square opening on the enclosure. This is the window the owner would look through to observe the fuel level of the tank. The oil spill occurred when he did not notify the person filling from the truck that the tank was full. See the EPA report for details on this spill and the so-called clean-up.

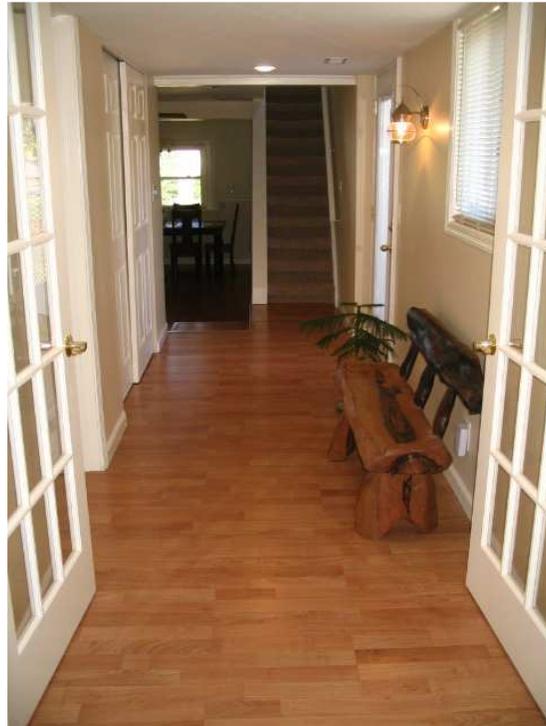
AFTER INITIAL RENOVATION OF HALLWAY (MARCH 2006)

This is a photograph from the same end of the hallway after renovations were made before we moved to the house in March 2006. The oil tank was removed. The vapor affected drop ceiling and drywall/insulation in the entire hallway was replaced. A door was installed to the exterior of the house where the oil tank used to be and oil affected wood was removed. The floor of the hallway was skim coated with concrete and a 6 mil plastic vapor barrier was put down under the wood laminate. Note: there was no smell of oil whatsoever for the first month or so. Then the oil vapor began to emerge from the corner of the hallway, underneath the door to the exterior, especially on rainy days. This is the lowest point in the floor, where the oil would have flowed and where the concrete slab of the hallway meets an interior cinder block wall (originally an exterior wall of the house but subsequently enclosed). The house was closed without ventilation for a week at the end of June and when we returned the oil smell was noxious throughout the house.

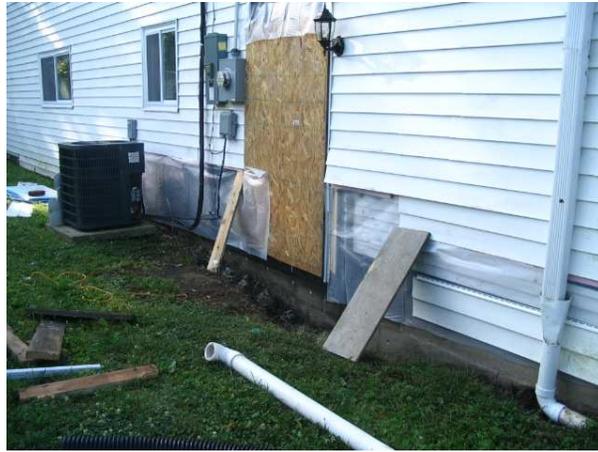
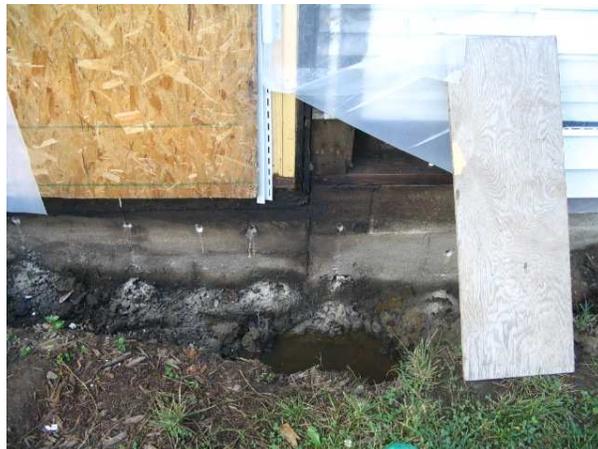
OUTSIDE DURING DIGGING

Siding was removed at the bottom of the house in the oil spill location and oil saturated wood was removed. Oily dirt was removed. VaporRemed was sprayed in this area and onto the concrete floor inside, but the odor remained. Holes were drilled into the cinder block outside the house and into the concrete slab inside the house. Gallons of VaporRemed were sprayed in both, but the oil smell returned through the floor and from the cinder blocks. This led to taking up the concrete slab of the hallway.

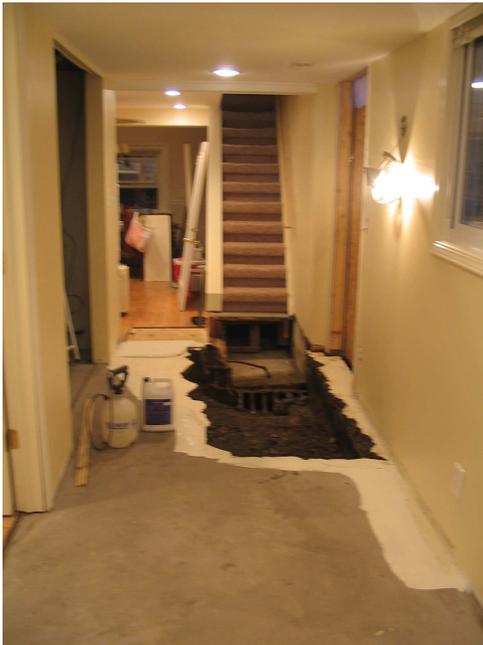
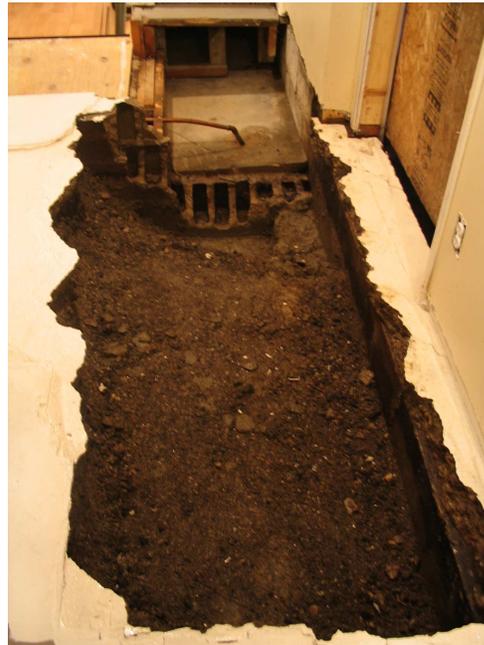
HALLWAY DURING DIGGING

These photos show an early stage of demolition and oil removal. The landing at the bottom of the stairs was removed and concrete/cinders/dirt was taken out by hand. VaporRemed was used during the process to keep the oil vapor from contaminating other areas of the house. Note the hollows of the cinder block at the end of the hallway. This was a low spot that the oil seeped towards. At this point the hope was that dirt could be removed and VaporRemed sprayed into the exterior cinder block foundation wall from both sides to deal with the problem. This proved unsuccessful and about 12-14 feet of the exterior cinder block foundation wall and 10-12 feet of the interior cinder block foundation wall had to be removed.

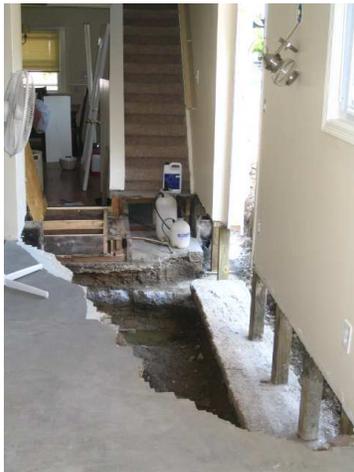
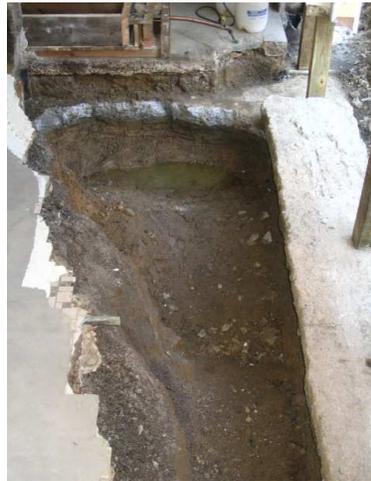
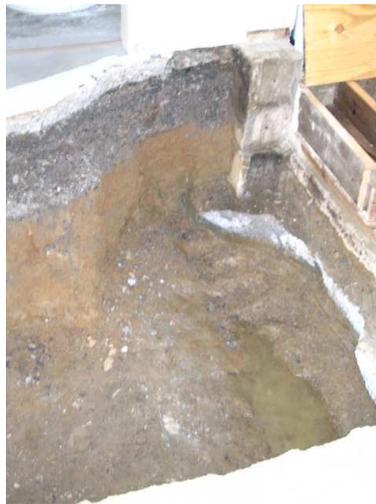
CONTAMINATED SOIL AND CINDER BLOCK REMOVED

The oil-saturated dirt was a greenish-gray color, in contrast to the brown that is visible in these photos. It emitted an extremely strong, sweet odor. Here you can see the cinder block foundation wall removed and contaminated soil removed below the level of the footer. The bottom photo shows the hole of about four feet in depth and the interior cinder block wall that still needed removed. This required removing the kitchen floor and one wall of the kitchen. VaporRemed was utilized again when all the contaminated areas were extracted. There was an oil odor, though significantly diminished, even after removal of the dirt and cinder block. Thanks to VaporRemed, though, even this slight odor disappeared and did not return.

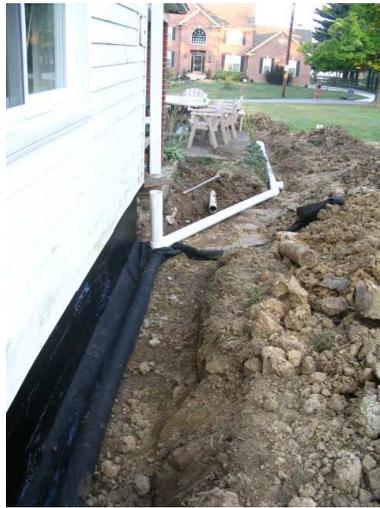
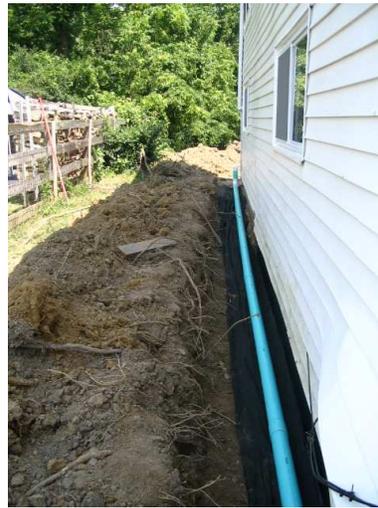
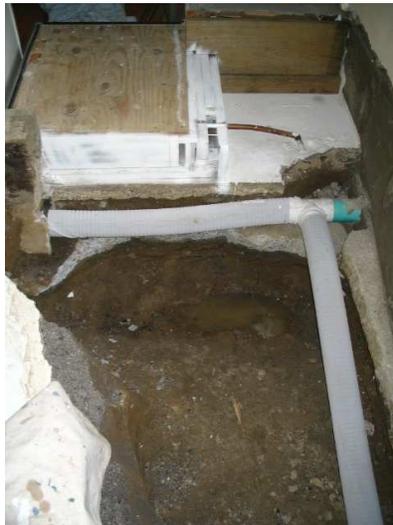
NEW FOOTER-DRAIN IRRIGATION SYSTEM INSTALLED

When the EPA treated the problem in March of 2005, then simply dug up some soil at the side of the house and blocked the old clay drain tile to prevent any oil seeping into the storm drain system which led to a creek ½ mile away. This creek is where the oil was first detected by neighbors. This created a new problem—water sitting alongside the house, right where the oil spill occurred, with nowhere to go but under the slab foundation and into the cinder block foundation wall. These photos show the new irrigation. Note in the bottom photo the perforated black pipe that connects the outside system to the inside of the house, in the hole where the oil affected dirt was removed. IF there was any future residual odor that surfaced under the hallway, it would rise through the fill gravel to the plastic vapor barriers and follow the perforated pipe outside.
