# SMEDJEBACKEN RAILWAY STATION, SWEDEN

**30 x 15 meters of railroad was cleaned with  
Sarva's AgroRemed single application**

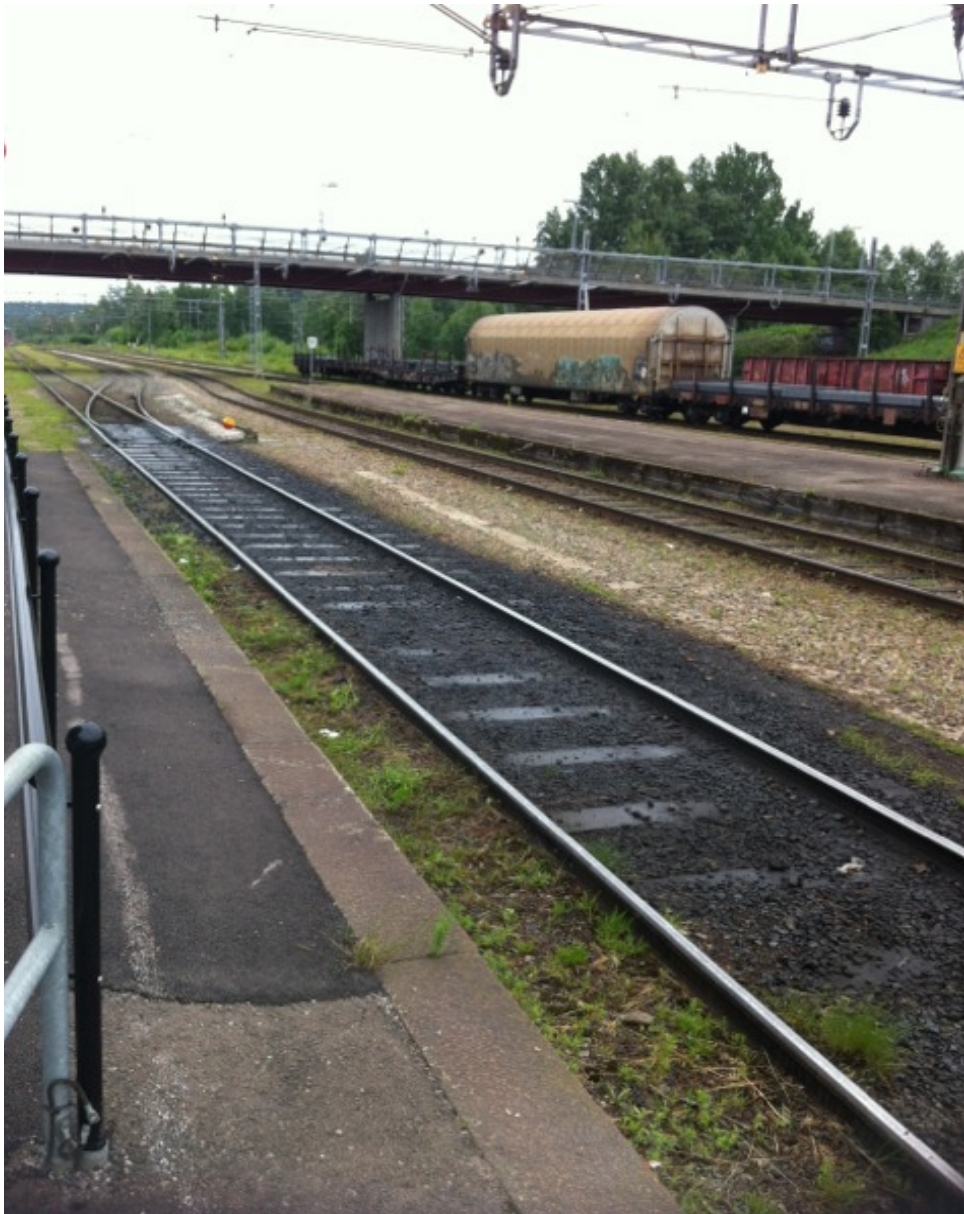
30 meters of railroad heavily contaminated during 80 years of small leakage from trains

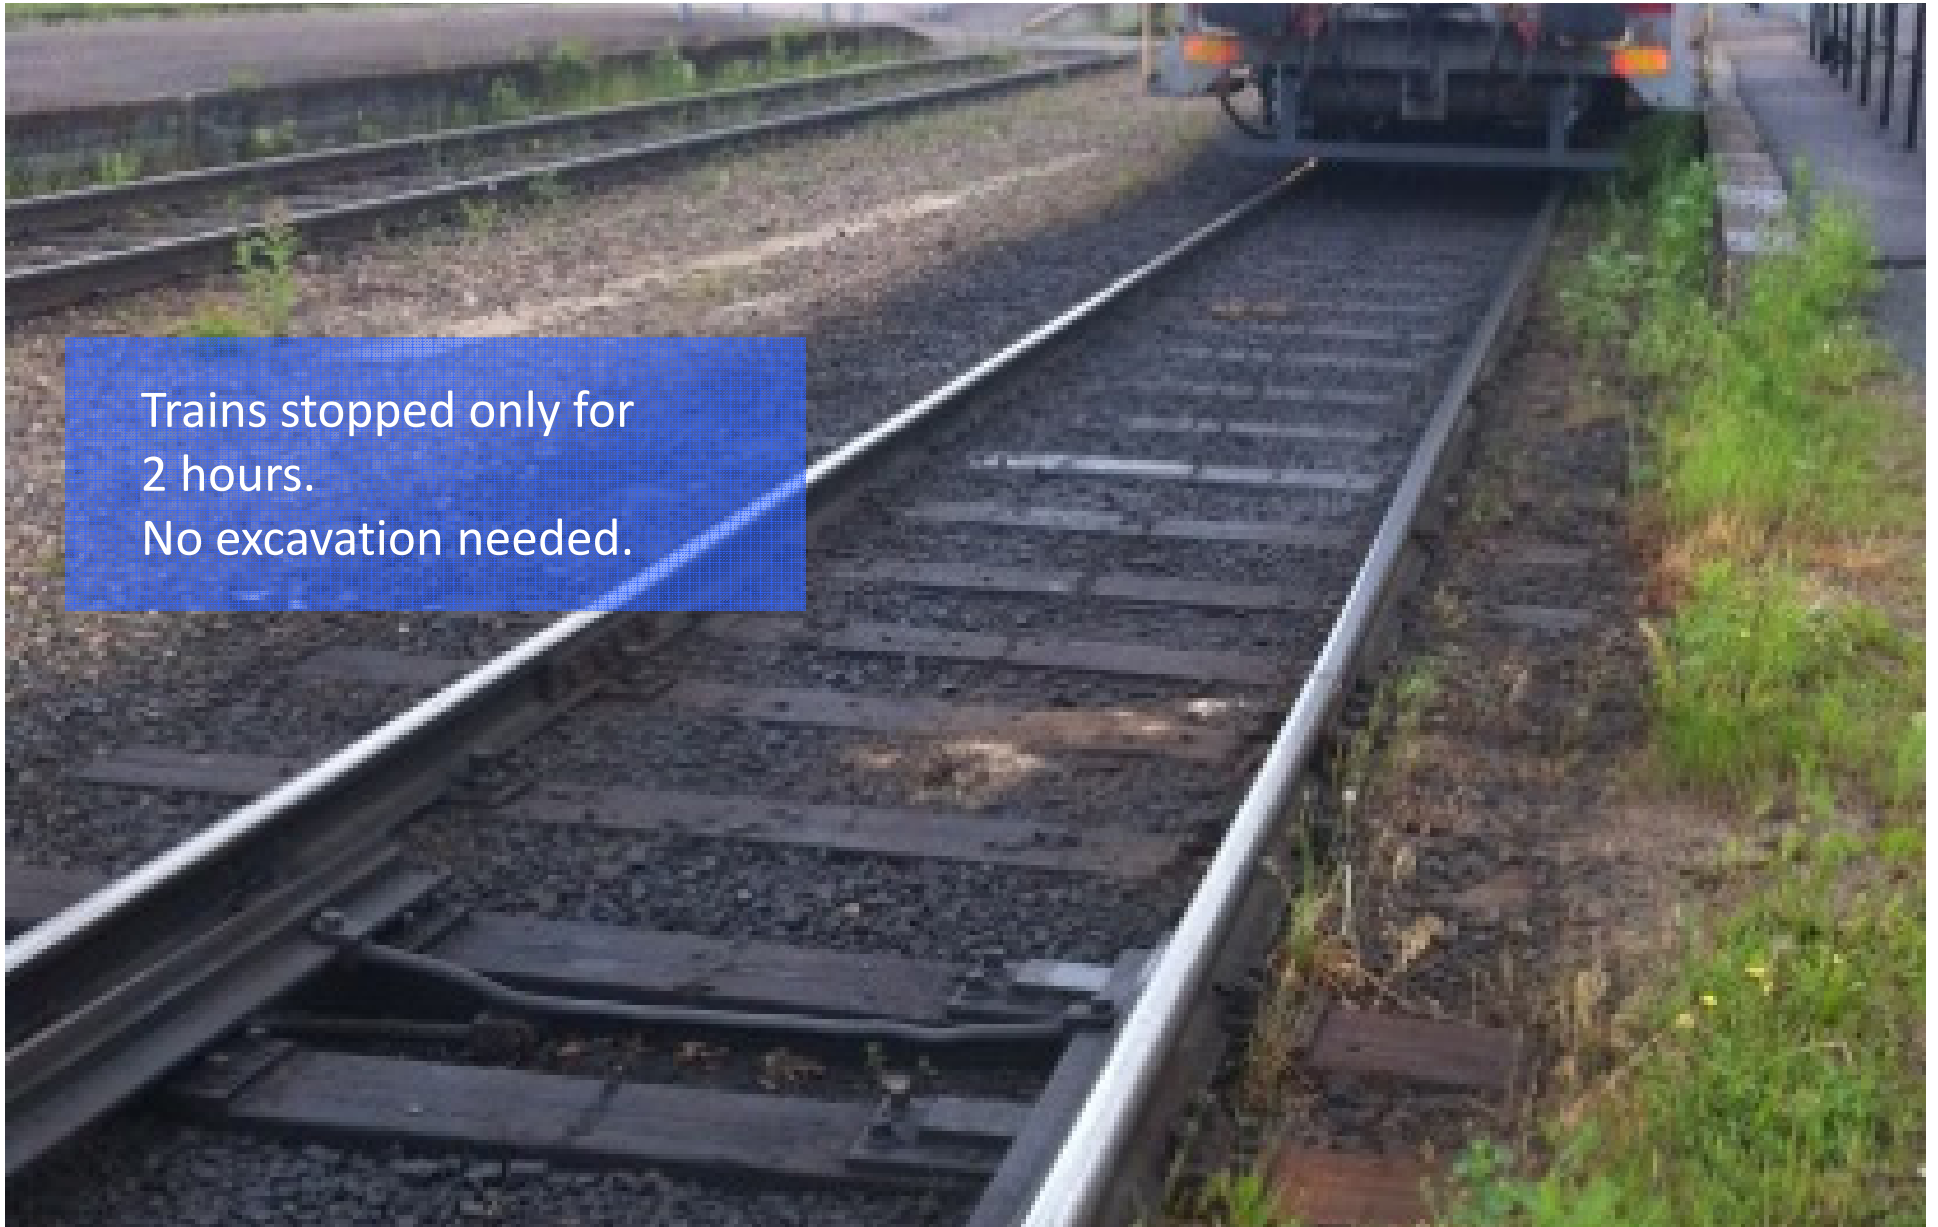
Trains stopped only for  
2 hours.  
No excavation needed.

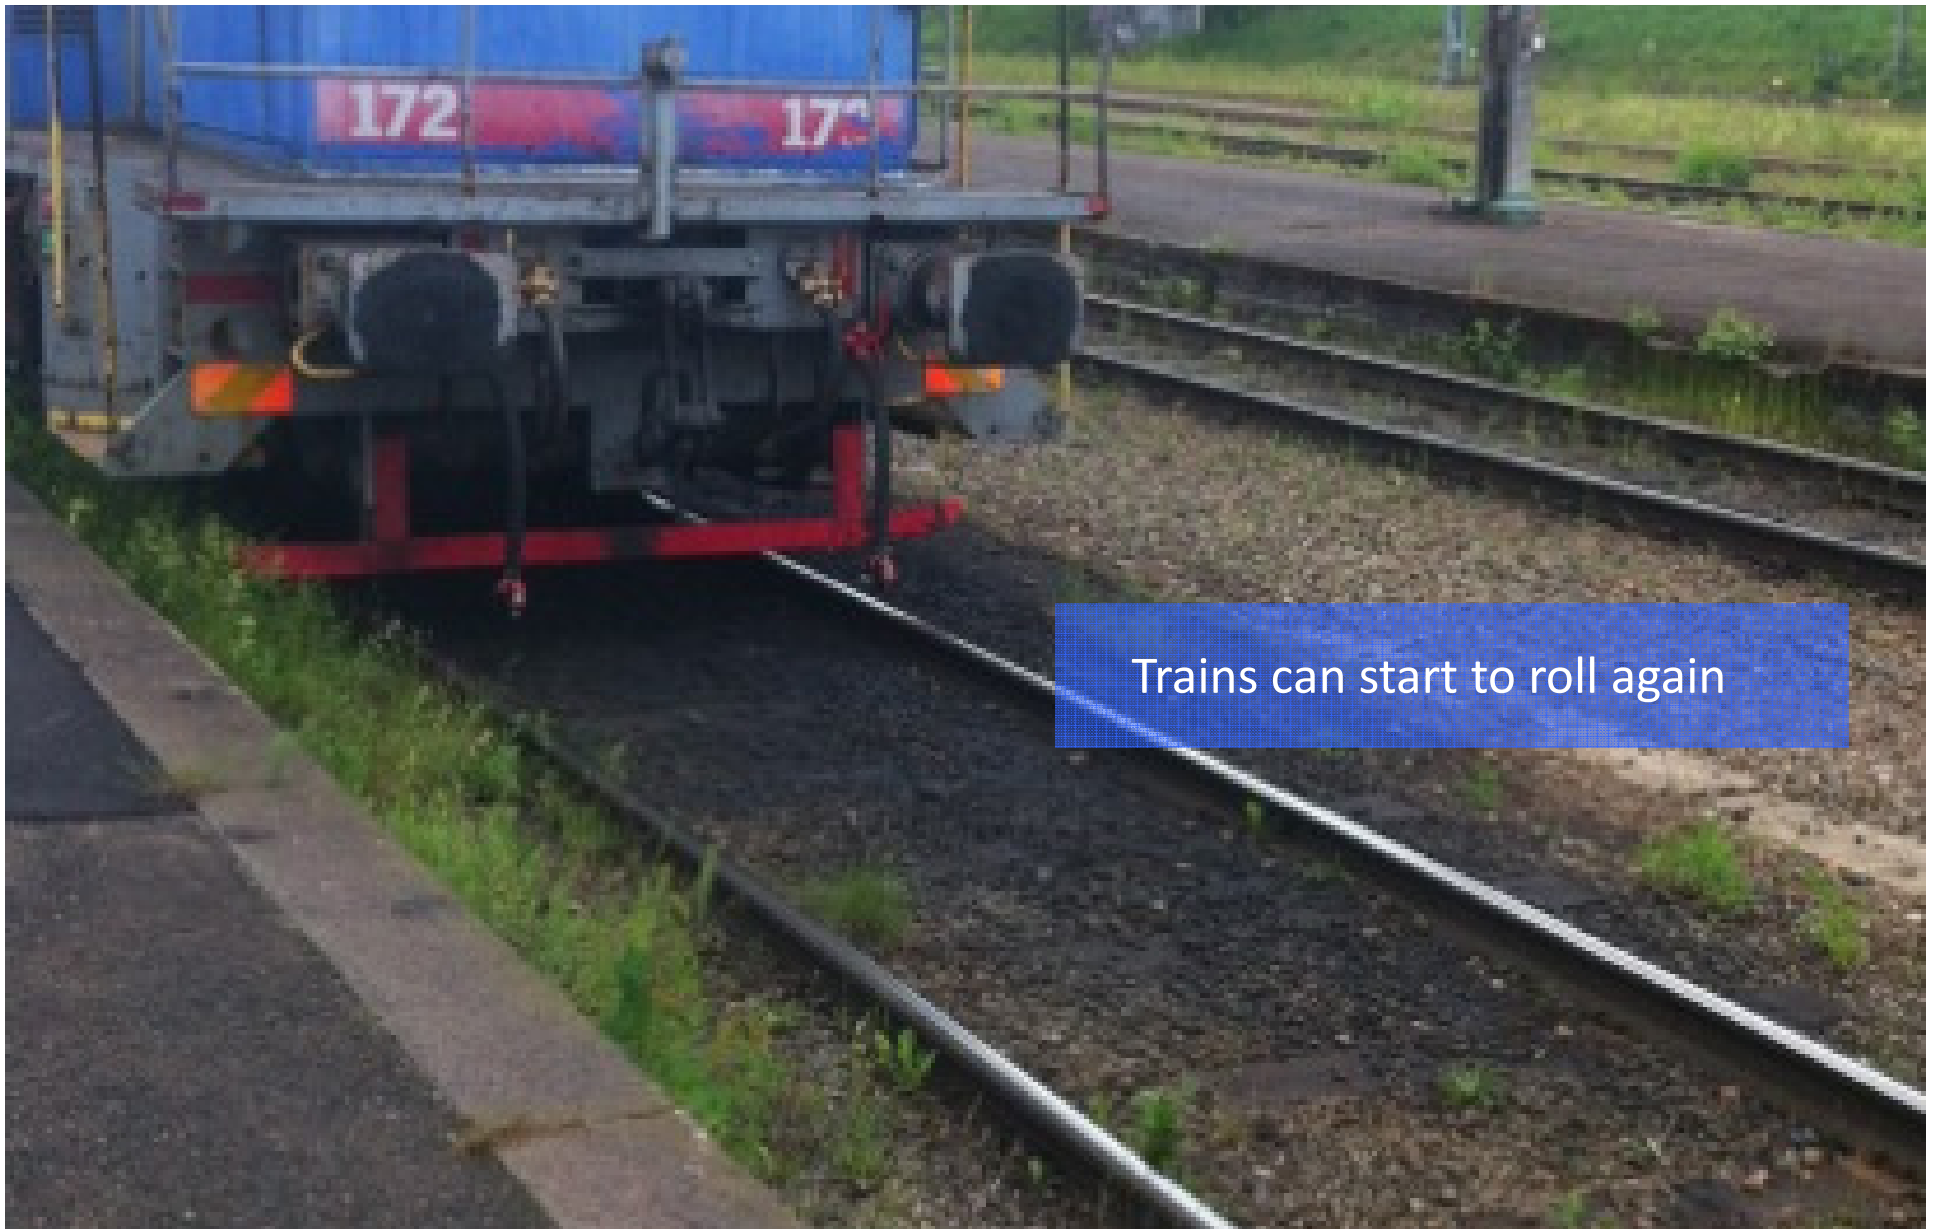
Trains can start to roll again
