## Cleanup of Contaminated Soils at Municipal Park

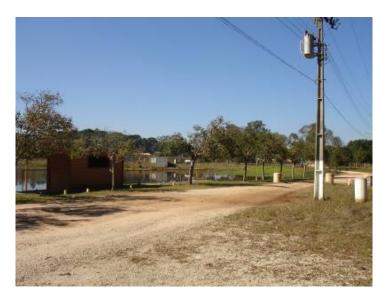
In March, 2006, in Fazenda Rio Grande, state of the Paraná, the vandals were responsible for the contamination of an area around 270 m<sup>2</sup> (2906 sq.ft) with transformer oil at the COPEL power electric transformer in the Municipal Park (Figure 1).

Figure 1. Contaminated soil of the Municipal Park.

Contamination of the soil appeared to extend to an area for 270 m<sup>2</sup> (visible) and the soil analyses, after one month, indicated the migration of the mineral oil as evidenced by the low concentrations on the surface, thus increasing the possibility of contamination of ground water. Tables 1 and 2 show the results of TPH in the soil.

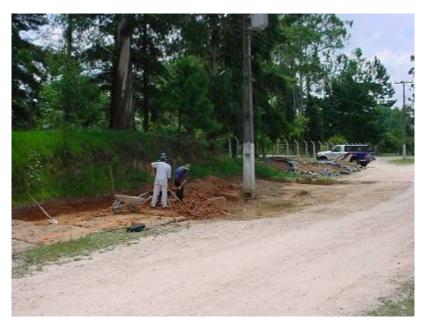
In order to prevent the removal of uncontaminated soil and to reduce the volume of material to be treated, the excavations were made of ditches at different depths and evaluated the levels of contamination. Initially, the excavated area was divided in 6 squares (Figure 2). A preliminary analysis indicated that soil should be removed up to 50 cm but then it was decided to that the excavations would be continued till the TPH value reaches below 50 mg of oil for kg of soil. (Tables 3, 4, and 5)

Figure 2. Excavation of the contaminated soil.

The analysis of the soil samples results of the soil near 70 cm, showed an average value of 36 ppm, which was lower than the stipulated value 50 mg/Kg. so further excavations were discontinued. A total of 10 piles/stacks of soil were treated with AgroRemed BR CTBA.

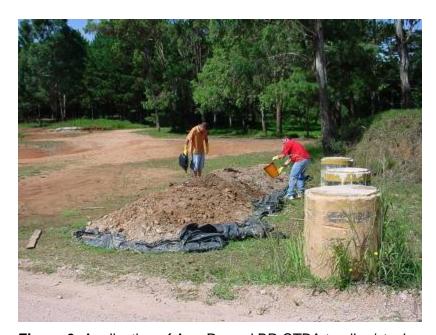
The soil excavated in the previous four stacks was spread on impermeable canvas and samples were collected and sent for analysis of Total Petroleum Hydrocarbons before the beginning of the treatment. Collected the samples, the process of material remediation were initiated. AgroRemed BR CTBA was sprayed on the four stacks of the excavated soils periodically mixing the soil for better the contact with all the soil in the stacks. The Table 6 shows the values of TPH before the treatment and Figure 4 shows the application of AgroRemed BR CTBA.

Figure 3. Application of AgroRemed BR CTBA to piles/stacks.

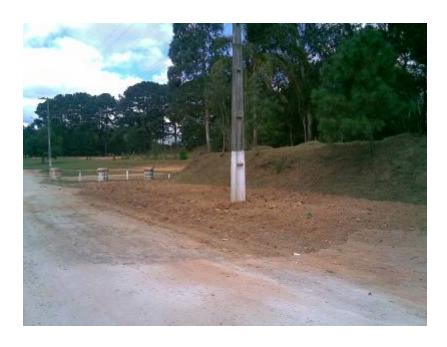
In order to close the project as per the environment laws of the country, the soil was analyzed for TPH, Benzene, Toluene, Xylene and PAH as shown in Table 12. The results indicated the values of these parameters within the accepted values. The ditches were closed with the treated soil and the project was closed as No Further Action required and the area was released for normal use for the Municipal Park (Figure 4).

Figure 4. Area refilled with the treated soil and is now open for public
