Cleanup at Mandirituba Power Sub Substation

Bioremediation of the Contaminated Soil

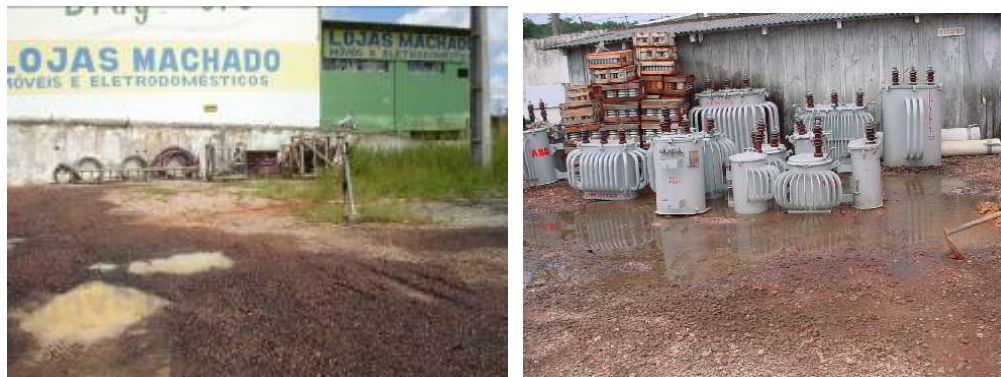
Figure 1 & 2. Mandirituba Power sub Substation and the transformers

In 2006, the Mandirituba power energy substation belonging to COPEL had many incidents of vandal attack on the unused equipment. As a result more than 15 transformers were damaged and the soil was heavily contaminated with transformer oil (Figure 1 and 2).

The utility company COPEL suggested on-site treatment as a remediation method, thereby avoiding transporting high volumes of contaminated soil. It was recommended to use of bioremediation for the cleanup and AgroRemed BR CTBA developed with local microbial source from Brazil by Sarva Bio Remed, LLC, USA was considered suitable when compared with the other available methods of cleanup.

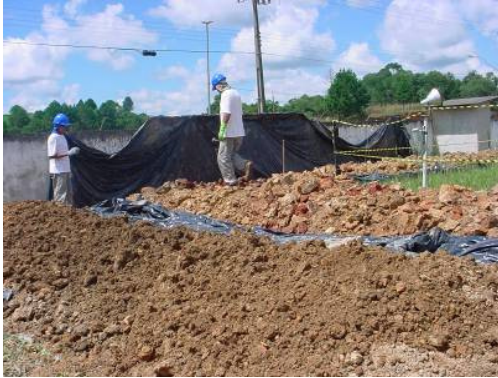
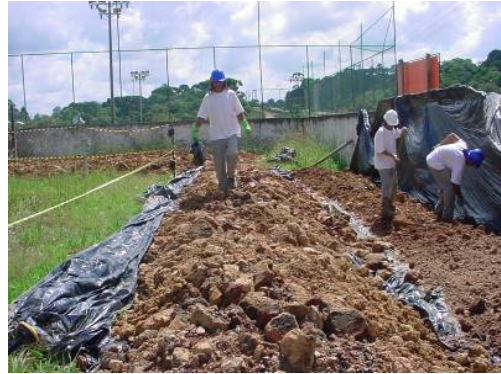
Figures 2 and 3. Excavation of contaminated soil and piled up as stacks.

The treatment of the Mandirituba power energy substation was initiated in February 2007. The project was similar to the Municipal Grounds project at the Fazenda Rio Grande except the area of contamination was larger. Treatment of soil was carried out by excavation and since the total area and the depth were greater, it was decided to divide the area in squares and treat each square one after the other. The first square was excavated and this resulted in 10 piles/stacks of soil (Figure 2). AgroRemed BR CTBA was applied on each stack uniformly after taking the samples of soil before treatment (Figure 3).

At the end of 4 weeks, fresh samples from each stack were collected and sent to LACTEC for analysis. The results were very promising and the value of TPH was almost 500 mg/kg as required by the local regulations (Tables 3 and 4). The excavated soil was replaced in the ditches and monitoring of the soil was continued till end of 2007.

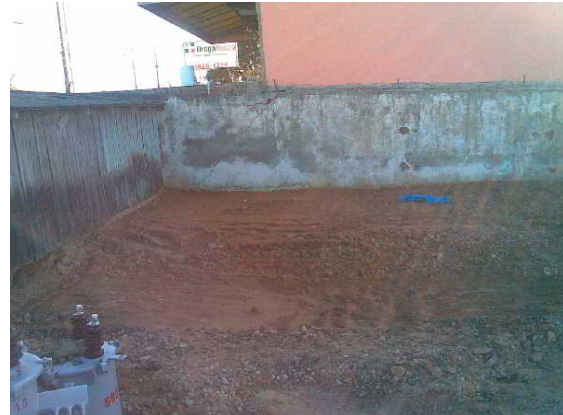
Figure 5. Soil filled back in the pits

The results are given below and as observed, the TPH values after 4 weeks were near the stipulated values and site was refilled with the same soil.
