# SPILL CLEANUP OF FUEL CONTAMINATED SOILS AFTER ROADWAY ACCIDENTS USING IN SITU BIOREMEDIATION

Satya Ganti<sup>1§</sup> and Bob Frye<sup>2</sup>

<sup>1</sup>*Sarva Bio Remed, LLC, NJ;* <sup>2</sup>*GEC Environmental Contracting Corp., VA*

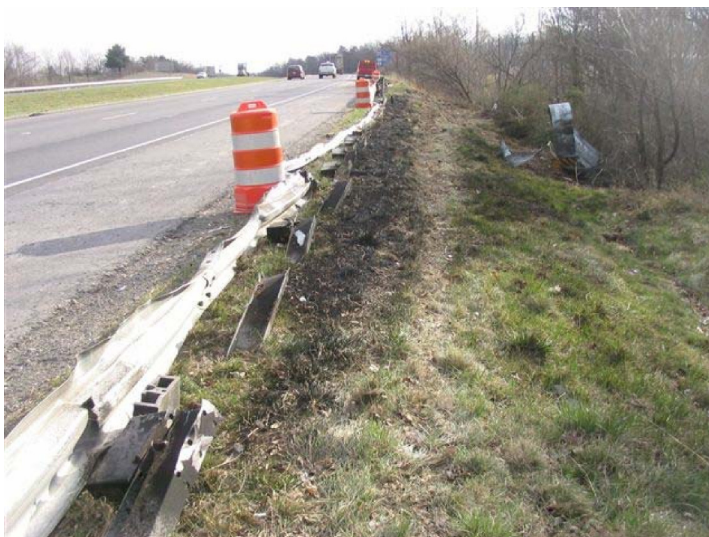
A tractor/trailer was involved in a highway accident, resulting in the release of approximately 100 gallons of diesel fuel from a ruptured saddle tank and ten gallons of motor oil from the truck engine. The wreckage ended at the bottom of the embankment, immediately adjacent the opening of the subsurface storm piping. Diesel fuel, released from the truck, flowed into soil immediate the wreckage and the open ditch. Several hundred feet of guardrail was destroyed in the accident, causing engine oil to disperse over approximately 100 feet of vegetation at the pavement edge. GEC Environmental Contracting Corp. (GEC) was contacted to provide clean up of the release. The wreckage and the site are seen in Figure 1.

Figure 1. The accident site and the wreckage of the truck.

Discussions were held with representatives of the Virginia Department of Transportation (VDOT) and implications of soil removal in this area were reviewed. The spill site was on a slope and it would be difficult to use mechanized cleanup vehicles for the cleanup. Excavation of the soil was not considered as an option for the cleanup.

It was agreed that this site is suitable for evaluation of on-site (in situ) bioremediation cleanup of highway spills. AgroRemed manufactured by Sarva Bio Remed, LLC was selected for direct application to the release point and affected soil and vegetation. AgroRemed has a track record for successful cleanup of contaminated soils after spills of diesel or heating oil both in residential and industrial facilities. AgroRemed has shown reduction in TPH values by 90% in

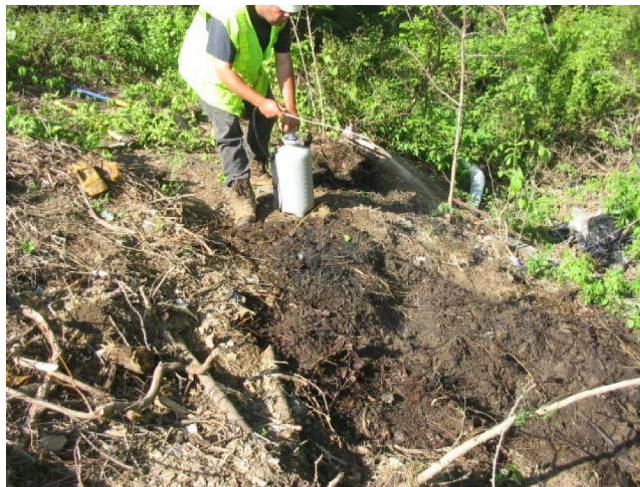
*Figure 2.* Application of AgroRemed to impacted soils

A soil sample was collected from the center of the diesel staining, approximately 2” below the surface. It showed a concentration of 65,000 parts per million (ppm). Impacted soil saturated with diesel was manually turned/ tilled to allow natural oxygenation before application of AgroRemed as seen in Figure 2.

A soil sample was collected after 20 days of application from this location and analyzed for TPH/DRO values and the results of hydrocarbon range C-5 to C-30 showed a value of 26,000

ppm or more than 40% reduction in the value. Application of AgroRemed was continued at regular intervals; it was noticed that the TPH/DRO was reduced from 26,000 ppm to 11,800 ppm because of drought conditions, and the soil was very dry. The conditions became favorable in September before the final application, and this time soil was sprayed with water from a tanker immediately before application of AgroRemed. In addition to the wetting, the surface of the soil was also covered with straw mulch to prevent excessive evaporation. The TPH of the soil was examined after 15 days and the levels of TPH were reduced to 650 ppm with no signs of tainting of the grass and interestingly no diesel odor. Further, the area was found to support healthy growth of grass and other vegetation indicating no residual toxicity and restoration of the soil to its condition before the spill. The DEQ agreed that there was no further action required. The total time required for the cleanup was a total of 103 days for reaching the accepted levels of contaminant.

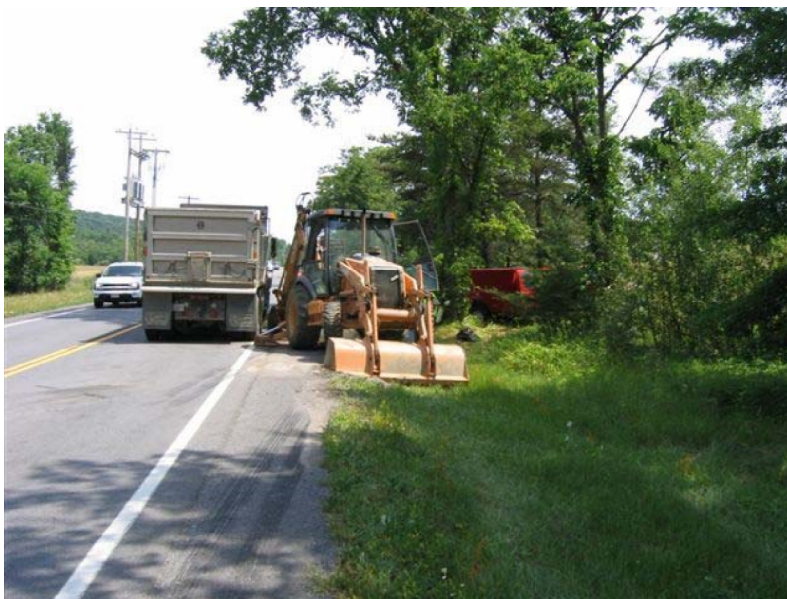
A tractor/trailer was involved in a highway accident, resulting in the release of approximately 75 gallons of diesel fuel from a ruptured saddle tank. Free petroleum product flowed into the gravel road shoulder and adjacent embankment. The site is a single lane, north/south highway of typical asphalt paved construction (Figure 3). Road shoulders are intermittent gravel, grass, and embankments. Potential receptors are humans, wildlife, and groundwater. Multiple major underground communication utilities lines were present in the accident area making it difficult to excavate.

Figure 3. Accident site showing the asphalted road affected by spill.

Diesel fuel had released on the pavement edge and gravel shoulder causing surface staining. Debris on the pavement was pushed to the gravel to allow normal traffic patterns for evening hours. Petroleum-absorbent booms were placed along the down-gradient edges of the spill area to prevent further migration during anticipated storm events. Anti-slip absorbent media was

applied to the impacted pavement and scrubbed to remove residual phase petroleum. As this material was spent, it was removed, and the process repeated until practical recovery was achieved. An additional application was then made as a slip preventative measure for traffic.
